BUILDING ENVELOPE EVALUATION REPORT

SUMTER COUNTY COURTHOUSE

209 North Florida Street
Bushnell, FL 33513-6146

January 12, 2010

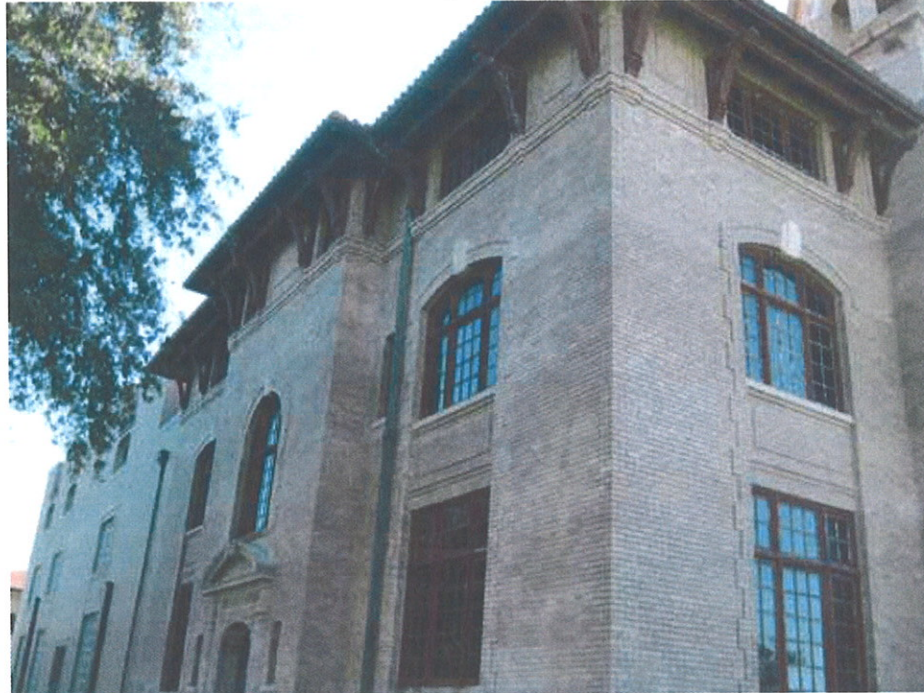
BRICK WALLS OF ORIGINAL COURTHOUSE.

Assembly Condition: The solid brick walls are in fair condition. Solid masonry walls rely upon their mass to prevent intruding rainwater from reaching the interior finishes. This is defined as the reservoir capacity of the wall.

Component Condition: Brick: The brick is generally intact with only a few broken or cracked brick. Some brick are stained from efflorescence and also possibly from a application of a dampproofing product. The only water intrusion attributed to this assembly is through the assembly located above the tile roof and above the roofs of the additions where through-wall flashings were not installed.

Mortar: The mortar was installed in the brick joints with a raked shape. This type of joint is very vulnerable to rainwater intrusion because rainwater does not drain from the exposed top surface of the brick and often intrudes through the adjacent mortar joint. Also, a limited number of mortar joints are cracked or missing.

Prognosis: The defective mortar joints should be repaired to prevent the reservoir capacity from being exceeded and to improve the appearance of the facility. With proper repairs and maintenance, the brick walls can be expected to remain effective through the life of the building.

Repair Approach: The most cost effective approach is the re-pointing of all existing mortar joints and replace with a more watertight joint type and the application of a clear dampproofing over all brick wall assemblies.

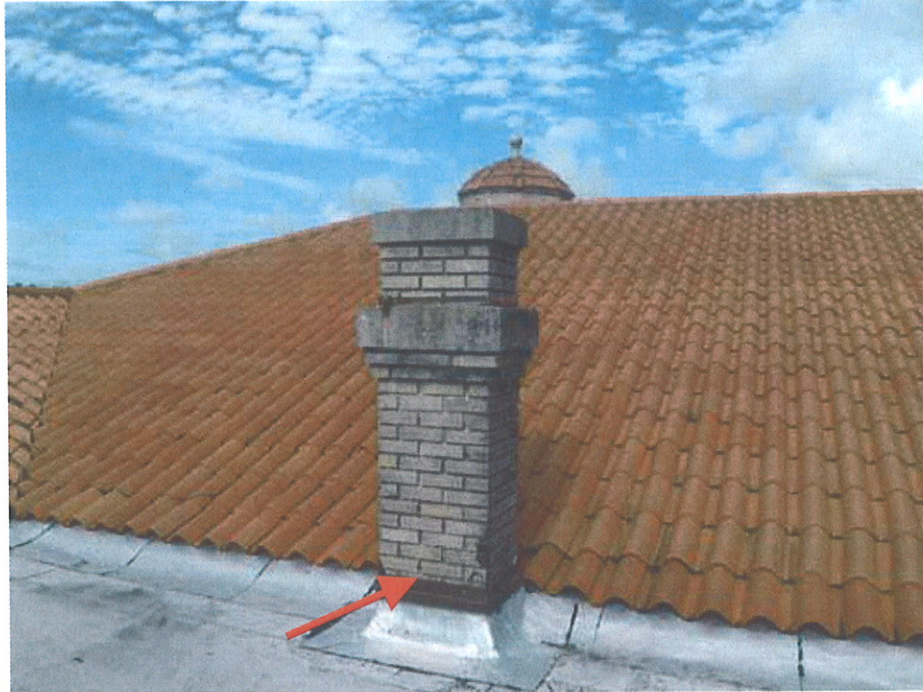
TYPICAL LACK OF DRAINAGE ABOVE TILE ROOF. NOTE SURFACE MOUNTED REGLET AT BASE OF BRICK WALL WHICH PREVENTS THE DISCHARGE OF WATER WHICH MIGRATES THROUGH THE BRICK ABOVE.

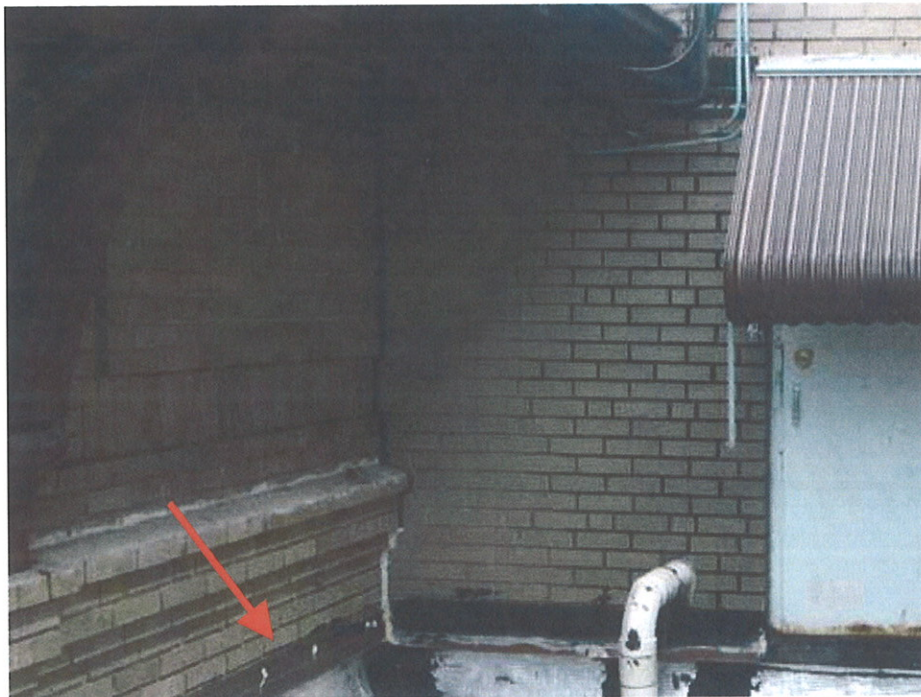
TYPICAL LACK OF DRAINAGE ABOVE ADDITION ROOF.

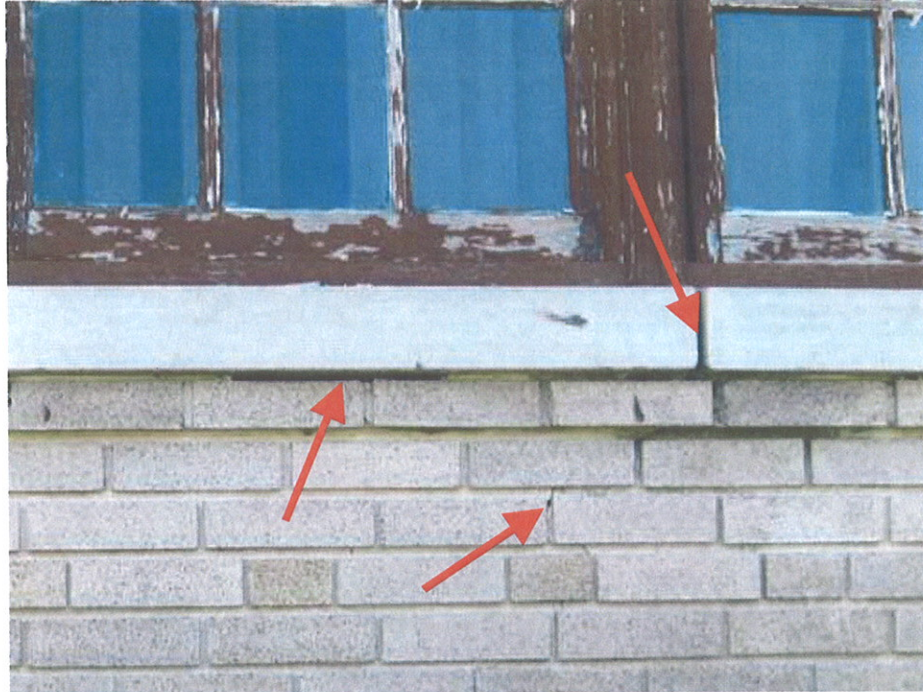
TYPICAL CRACKED AND MISSING MORTAR.

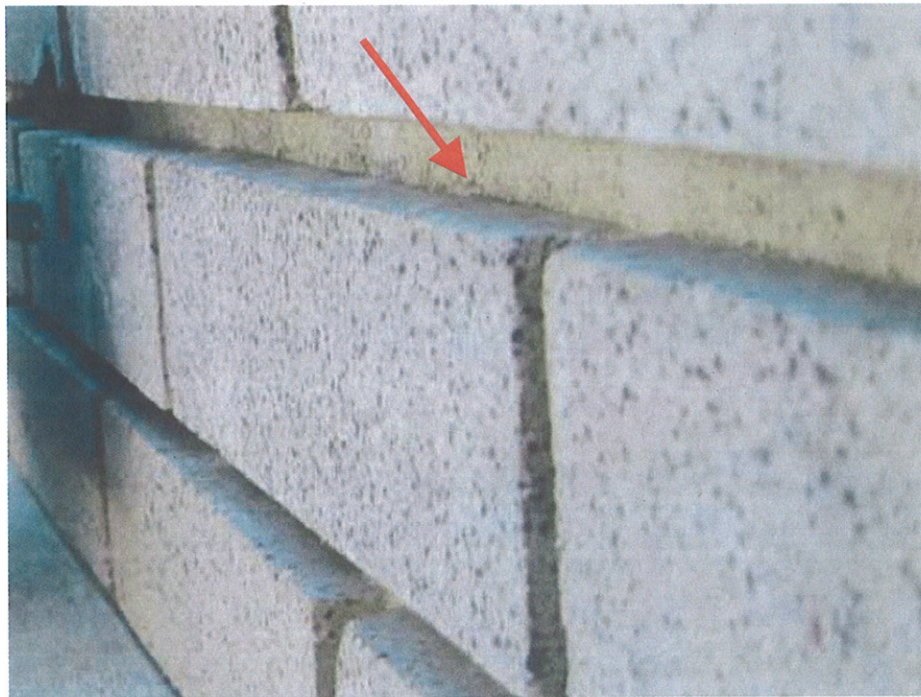
TYPICAL VULNERABLE RAKED MORTAR JOINT. WATER DOES NOT DRAIN FROM THE FLAT BRICK SURFACE AND OFTEN INTRUDES INTO MORTAR JOINTS.

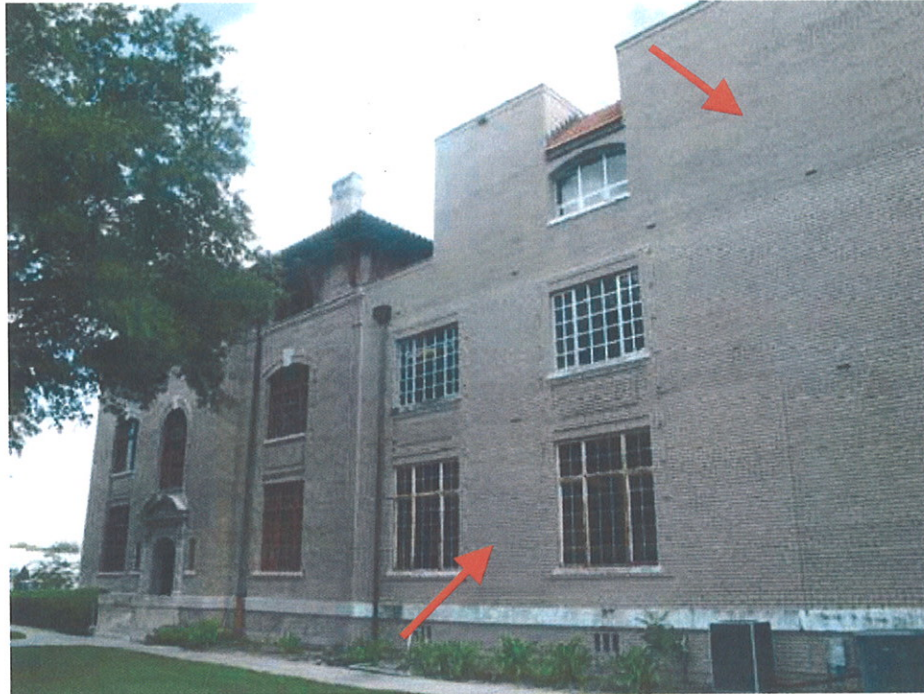
BRICK WALLS OF ADDITIONS.

- Assembly:** Exterior Wall Type 1 of 2 - Brick Veneer Walls
- Assembly Location:** Exterior walls of additions.
- Assembly Condition:** The brick veneer walls are in poor condition with numerous area of water intrusion which has damaged interior wall and ceiling finishes. The following distresses are contributing to the severe water intrusion at the additions.

- Component Condition:**
- Brick:** The brick is generally intact with only a few broken or cracked brick. However, because of the relatively small mass of brick veneer walls, the walls rely upon waterproofing applied over the substrate behind the brick. Waterproofing was **not applied** over some of the concrete block surfaces.

- Mortar:** The mortar was installed in the brick joints with a raked shape. This type of joint is very vulnerable to rainwater intrusion because rainwater does not drain from the exposed top surface of the brick and often intrudes through the adjacent mortar joint. Also, a limited number of mortar joints are cracked or missing.

- Prognosis:** This wall assembly will require extensive repairs and maintenance to remain watertight.

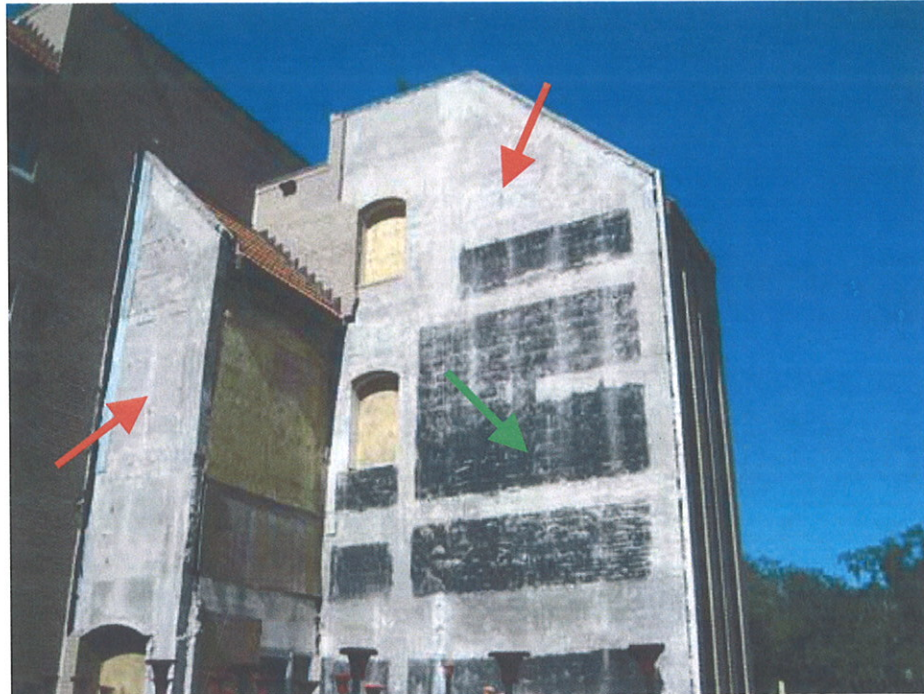
BRICK REMOVED FROM WALL DURING CURRENT CONSTRUCTION PROJECT. RED ARROWS POINT TO TYPICAL LACK OF WATERPROOFING ON CONCRETE BLOCK. GREEN ARROW POINTS TO BLACK WATERPROOFING APPLIED OVER CONCRETE BLOCK.

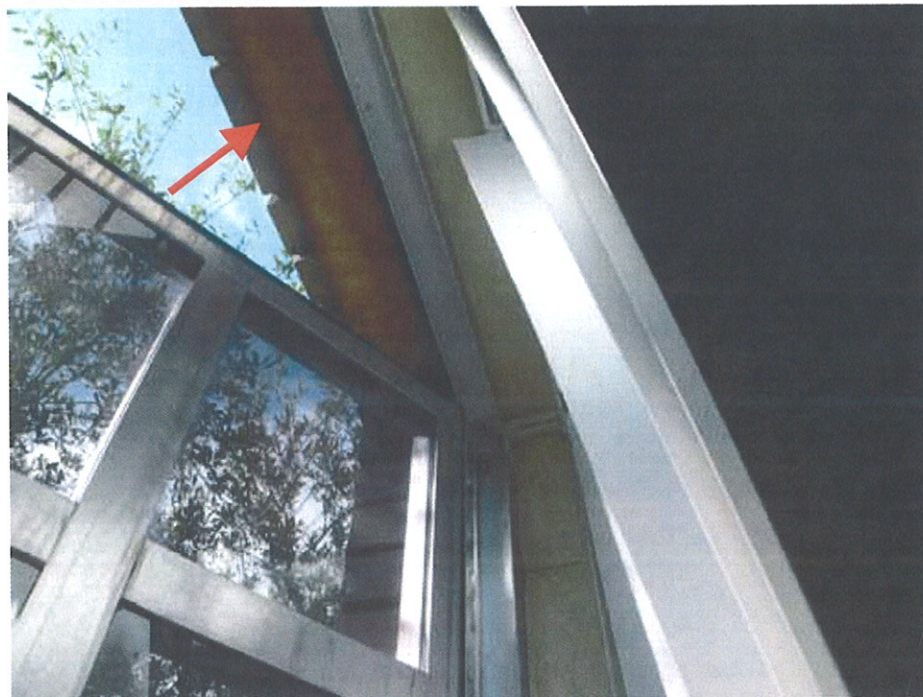
- Through-wall Flashings:** Through-wall flashings were not installed over the exterior windows and doors preventing the proper discharge of rainwater from the drainage cavity.

TYPICAL LACK OF THROUGH-WALL FLASHING AT LINTEL ABOVE WINDOW.

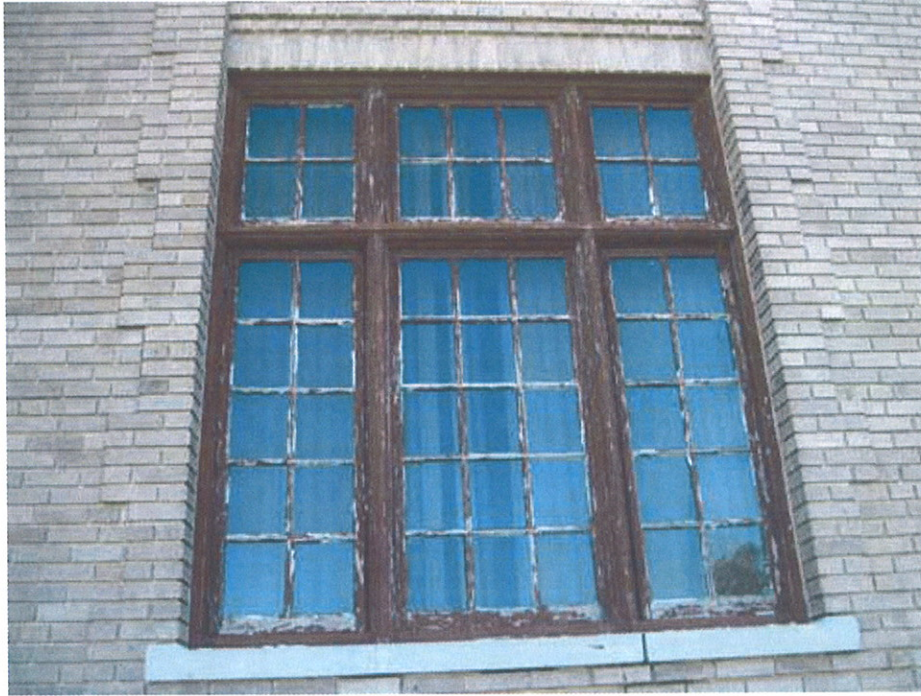
TYPICAL EXTERIOR WINDOW TYPE 1 OF 3.

- Assembly:** Exterior Window Type 1 of 3 - Wood Framed Windows of original courthouse.
- Assembly Location:** Exterior walls of original Courthouse.
- Assembly Condition:** Poor

- Component Condition:** **Window Frame, Muntins, and Sash:** The wood is deteriorated with many open joints and deteriorated wood. Termites have infested some of the windows.

- Finish:** The windows have been repainted numerous times. The paint is severely deteriorated.
- Window Hardware:** The window hardware is no longer functional and the windows are now fixed.

- Prognosis:** The age of these windows is approximately 97 years. Numerous repairs would have to be completed to make these windows watertight and airtight. Termite damage repairs would require replacement of many window components. Because of the age of the windows, the most cost effective approach would be the replacement of the windows with an extruded aluminum window which replicates the historic significant appearance of the window.

- 2.1 Remove all existing windows and replace with an extruded aluminum, hurricane resistant window which replicates the historic windows of the original courthouse.
- 2.2 Replace all existing sealants with a silicon sealant and closed cell backer rod.
- 2.3 Remove three rows of brick above all existing windows of the additions, install through-wall flashing, and install new brick where the existing brick was removed.

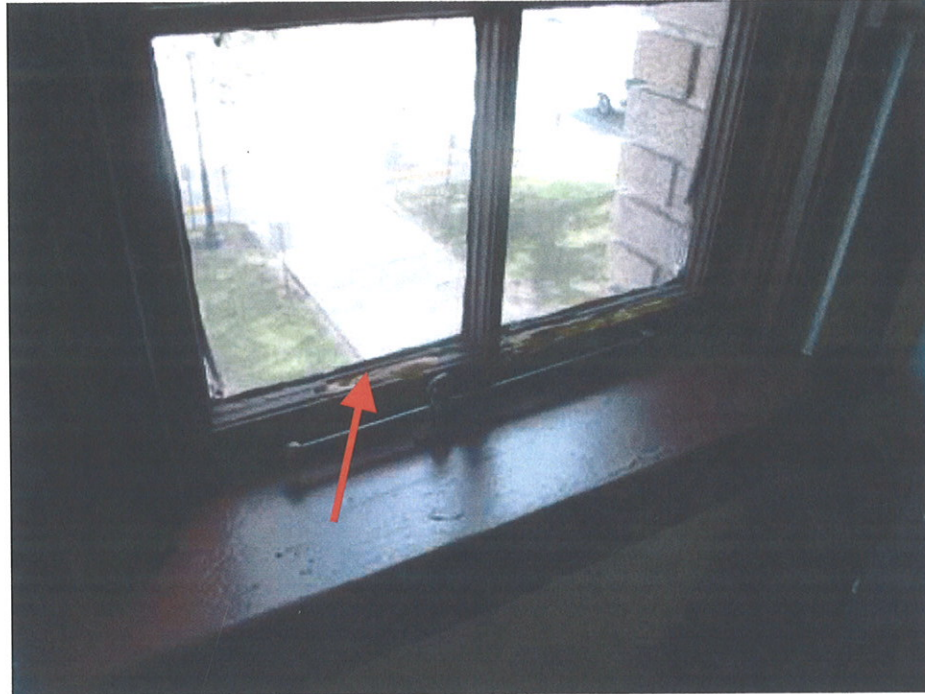
TYPICAL TERMITE DAMAGE.

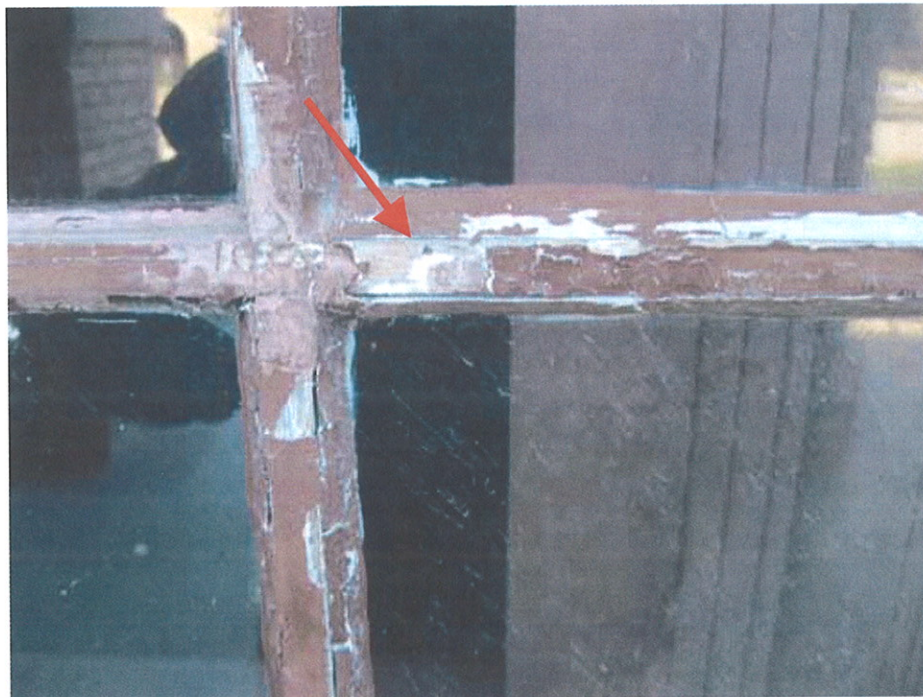
TYPICAL WOOD MUNTIN DETERIORATION.

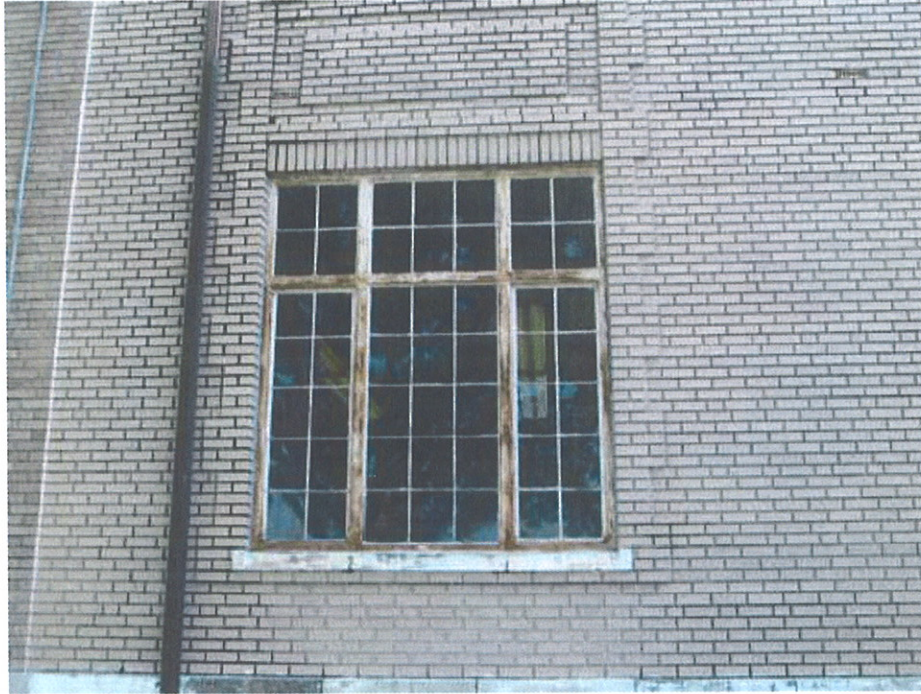
TYPICAL EXTERIOR WINDOW.

Assembly: Exterior Window Type 2 of 3 - Steel framed windows of addition.

Component Condition: **Window Frame and Muntins:** The painted steel is severely rusted.

Finish: Most of the painted finish is deteriorated exposing the steel to the atmosphere, and causing the corrosion of the steel.

Prognosis: The age of these windows is approximately 36 years. The frames are fabricated from steel which is prone to corrosion unless the exterior surfaces are extensively maintained. Because of the age of the windows, and because of the high cost to repair the corroded portions of the windows, the most cost effective approach is to replace the windows with a corrosion resistant material such as aluminum.

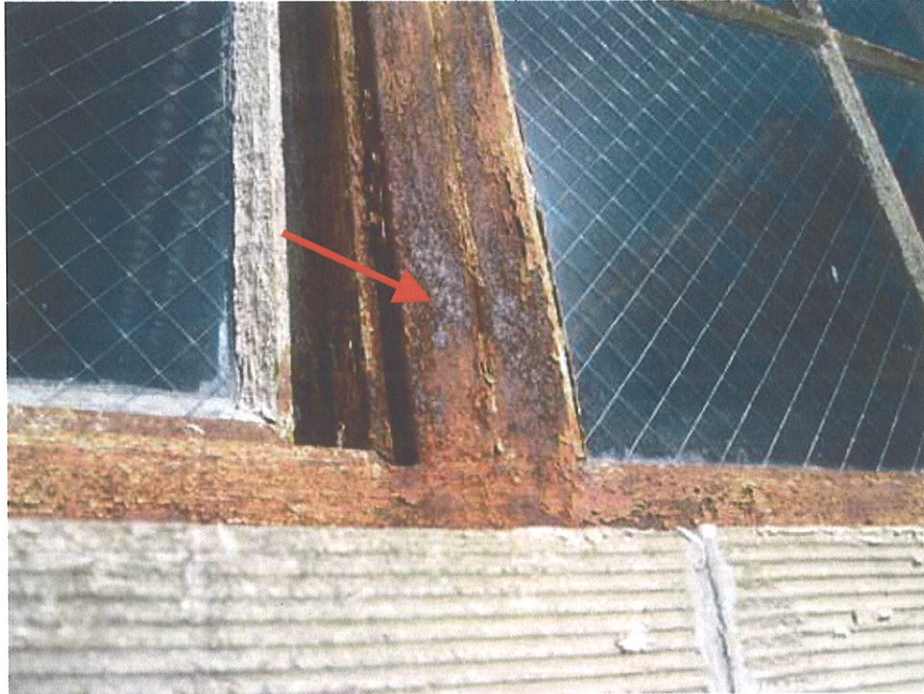
SEVERELY RUSTED FRAME.

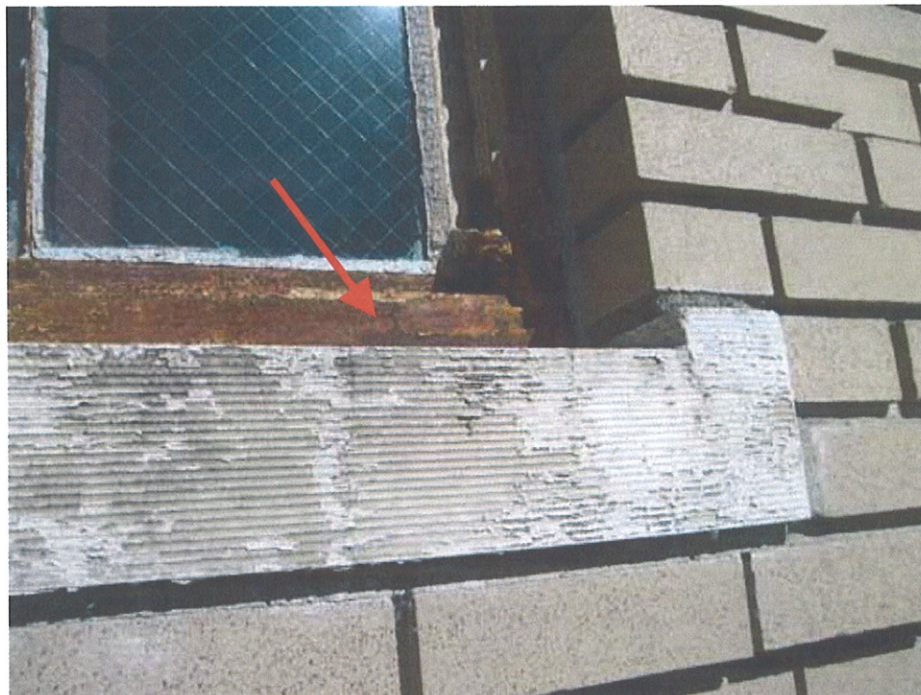
SEVERELY RUSTED FRAME.

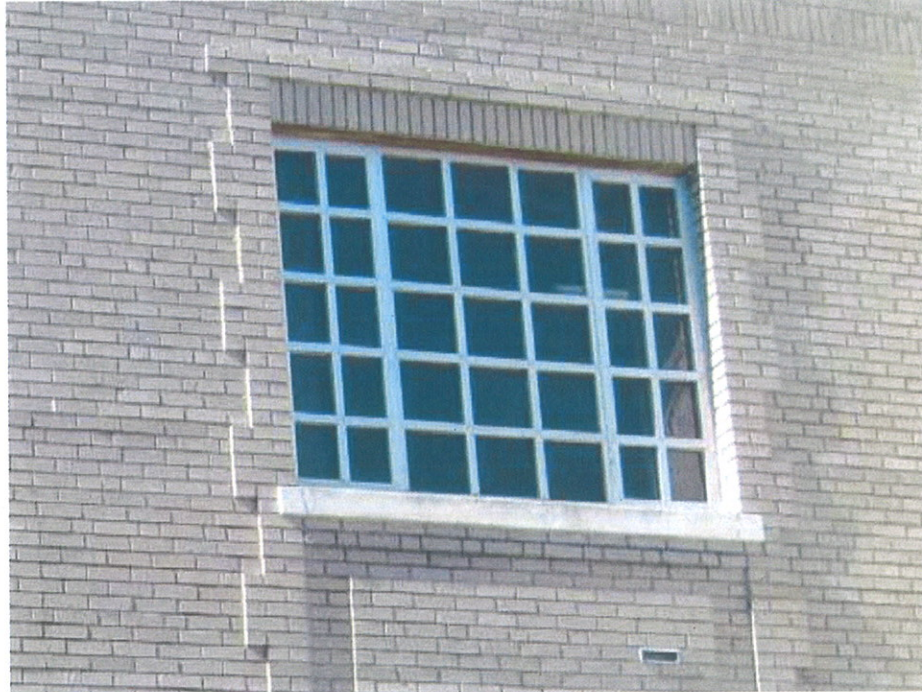
TYPICAL EXTERIOR WINDOW TYPE 3 OF 3.

- Assembly:** Exterior Window Type 3 of 3 - Aluminum Framed Windows of Addition
- Assembly Location:** Exterior walls of second addition.
- Assembly Condition:** Poor

- Component Condition:** **Window Frame and Muntins:** The frames and Muntins are in good condition, however, the metal to metal, metal to glass, and metal to brick joints do not appear to be watertight.

- Finish:** The mill finish of the aluminum is in good condition.
- Prognosis:** The age of these windows is approximately 25 years. The frames are fabricated from aluminum and are still in good condition. However, many of these windows are leaking. The source of the water intrusion has not been confirmed. The most probable path of the water intrusion is through unsealed joints associated with the window assembly. The other contributing source of the water intrusion may be the lack of through-wall flashings and the lack of waterproofing behind the brick veneer which is described in the evaluation of Wall Type 2. Because of the age of the windows, and because of the high cost to repair the window joints, the most cost effective approach is to replace the window with a corrosion resistant material such as aluminum.

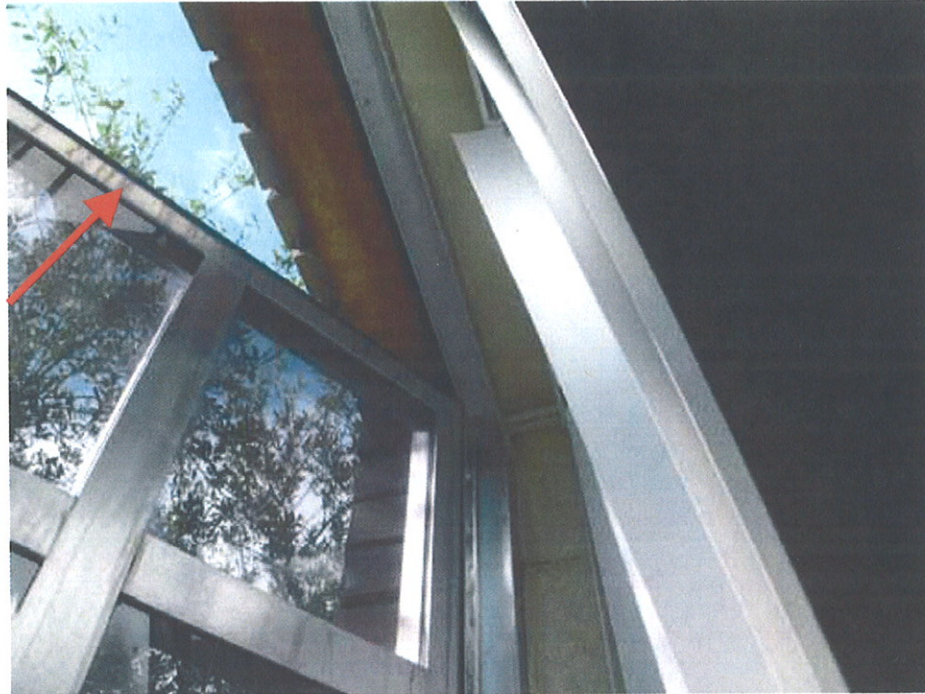
WATER STAINED SASH OF WINDOW TYPE 3.

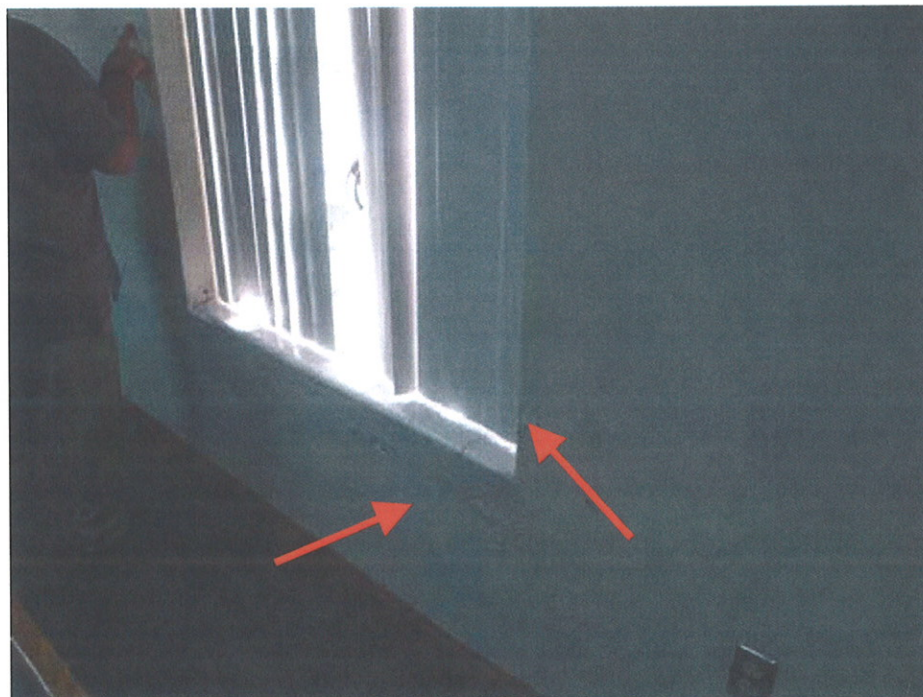
WATER INTRUSION BELOW AND ADJACENT TO WINDOW TYPE 3.

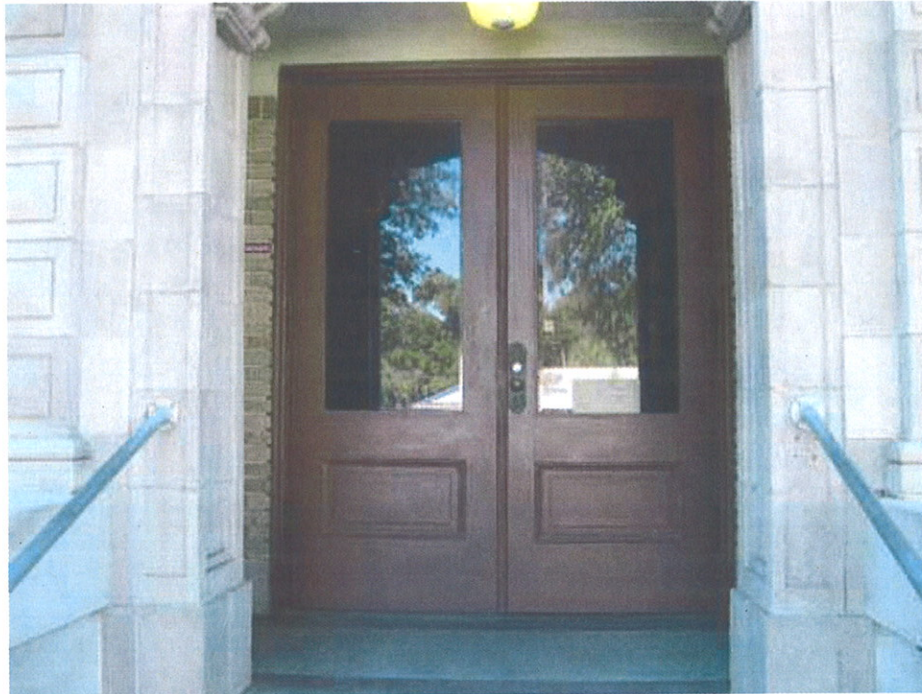
TYPICAL EXTERIOR WOOD DOOR OF ORIGINAL COURTHOUSE.

- Assembly:** Exterior Door Type 1 of 2 - Wood Framed Door of Original Courthouse.
- Assembly Location:** Exterior walls of Original Courthouse.
- Assembly Condition:** Poor

- Component Condition:**
- Door Frame:** The wood is deteriorated with many open joints and deteriorated wood.
 - Door:** The doors are in relatively good condition with minor deterioration.

- Finish:** The painted finish of the frame and door is slightly deteriorated.
 - Door Hardware:** The door hardware has been maintained and is in relatively good condition.

- Prognosis:** The age of the door frames is approximately 97 years. Numerous repairs would have to be completed to make these frames watertight and airtight. Because of the age of the frames, the most cost effective approach would be the replacement of the frames with an extruded aluminum frame which replicates the historic significant appearance of the frame. Although the door could be reused, the replacement of the door with a solid wood paneled door would provide a door assembly which complies with current building codes and a total assembly warranty. The current age of the wood doors is unknown.

- 3.1 Remove all existing windows and replace with an extruded aluminum, hurricane resistant doors which replicates the historic doors of the original courthouse.
- 3.2 Replace all existing sealants with a silicon sealant and closed cell backer rod.
- 3.3 Remove three rows of brick above all existing doors of the additions, install through-wall flashing, and install new brick where the existing brick was removed.

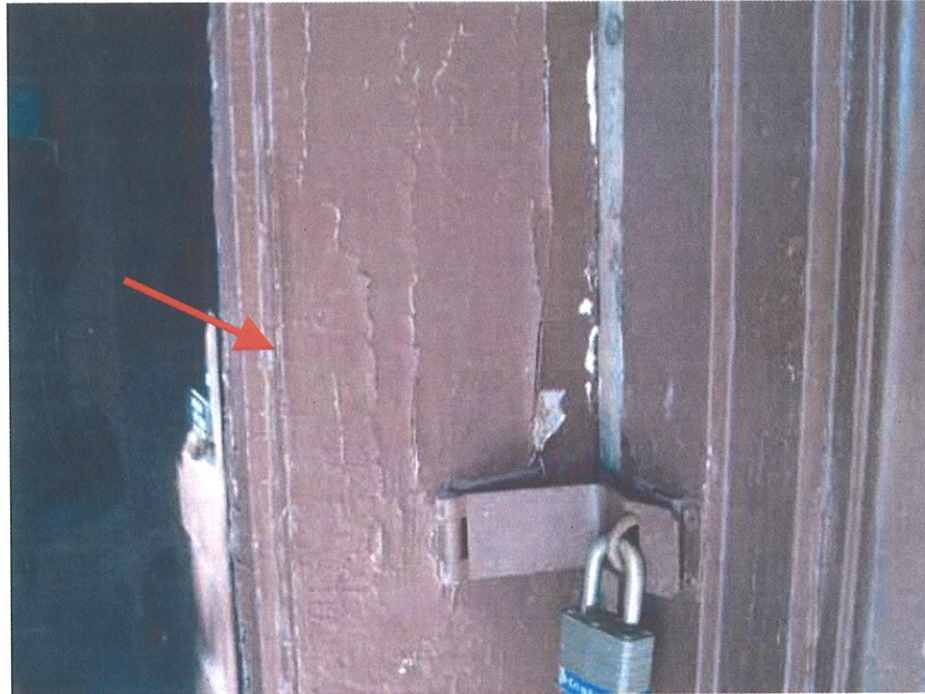
DETERIORATED WOOD FINISH.

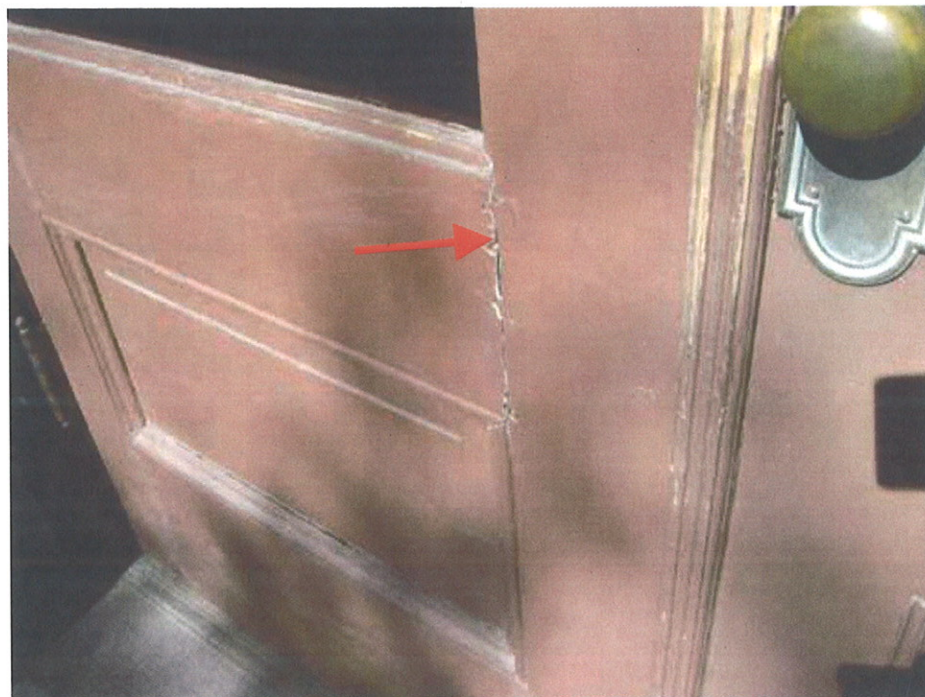
UNSEALED WOOD JOINTS..

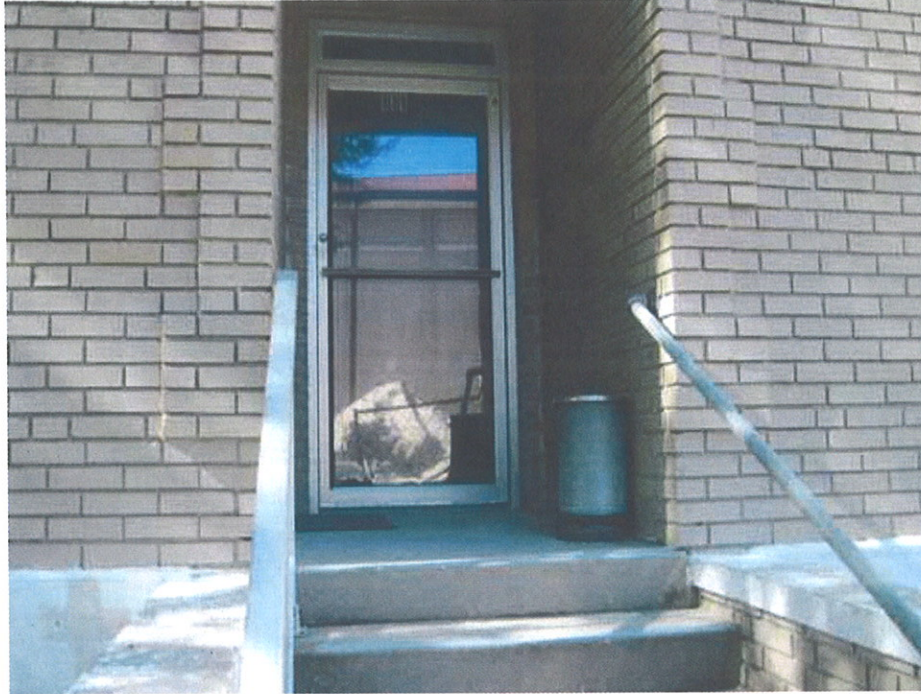
TYPICAL EXTERIOR ALUMINUM DOOR OF ADDITIONS.

- Assembly:** Exterior Door Type 2 of 2 - Aluminum Framed Door of Additions.
- Assembly Location:** Exterior walls of additions.
- Assembly Condition:** Fair

- Component Condition:**
- Door Frame:** The aluminum is in good condition. However, the metal to metal, metal to glass, and metal to brick joints do not appear to be watertight..

- Door Hardware:** The door hardware has been maintained and is in relatively good condition.
- Prognosis:** The age of these doors is approximately 37 years. The frames are fabricated from aluminum and are still in good condition. The doors are protected under large overhangs. Because of the age of the doors, and because of the high cost to repair the door joints, the most cost effective approach is to replace the window with a corrosion resistant material such as aluminum.

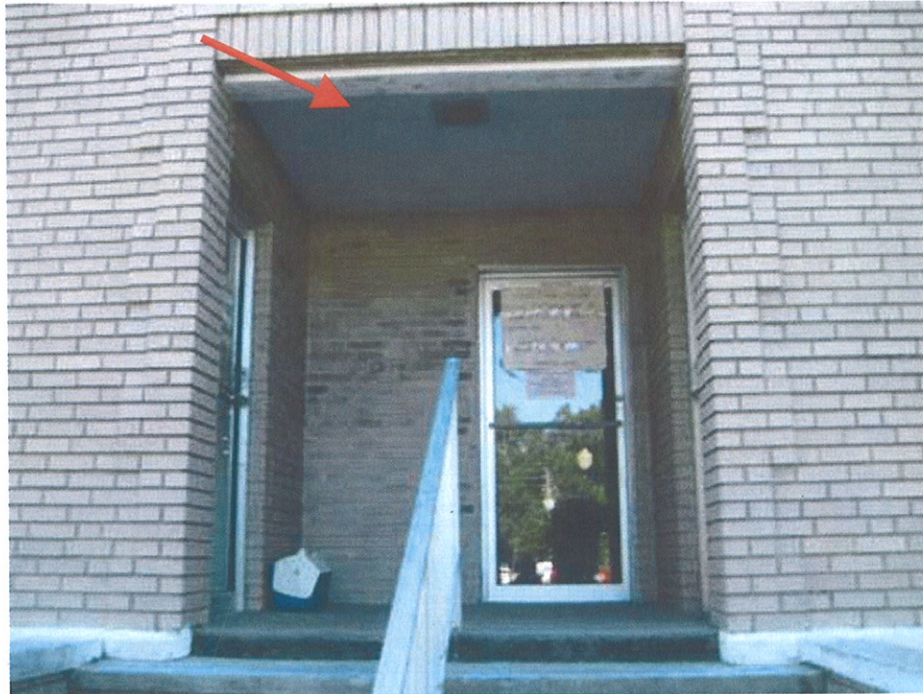
DOOR TYPE 2 OF 2 PROTECTED UNDER OVERHANG.

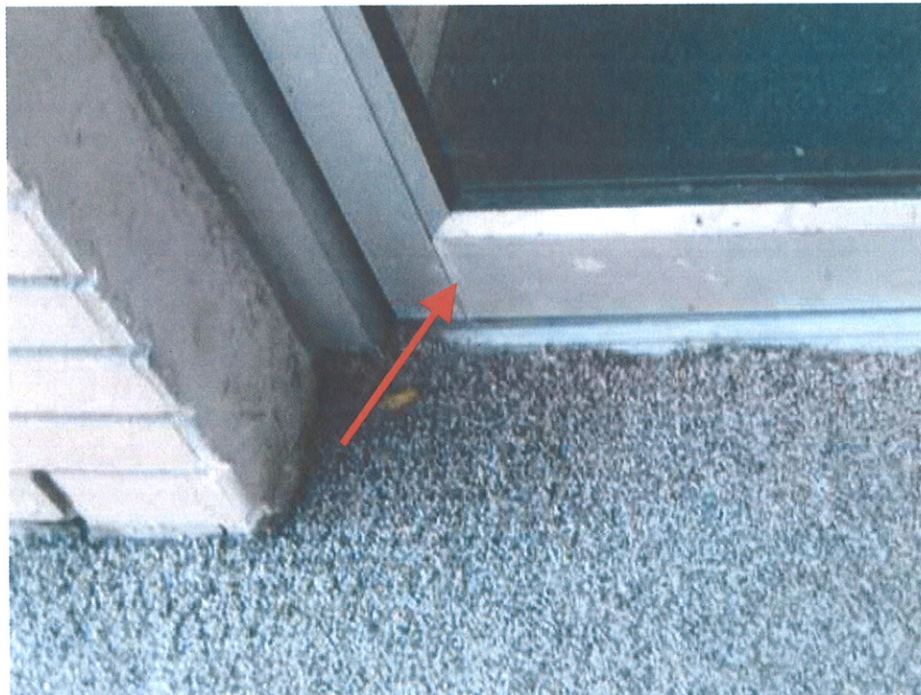
DETERIORATED METAL TO METAL JOINT.

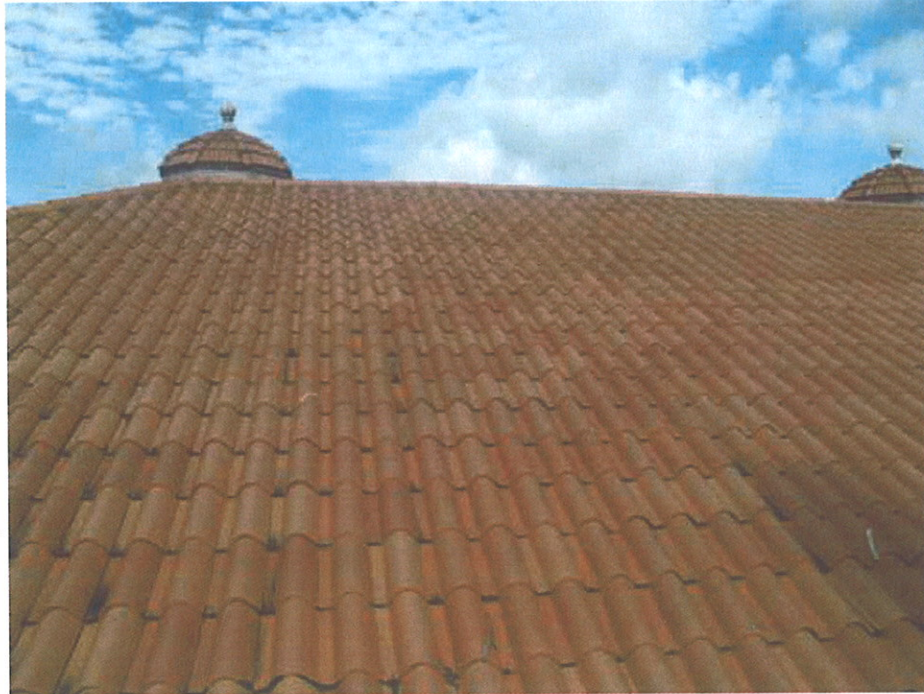
TILE ROOF ON ORIGINAL COURTHOUSE.

Assembly: Roof Type One of Three - Clay Tile

Assembly Condition: Good

Component Condition: **Tile:** The clay tile was replaced approximately 9 years ago and is in generally good condition. The tile is mechanically attached to the substrate. Although most of the tile appears to be properly secured, some tile have been displaced and should be replaced.

Eaves: The paint of the eave and eave rafters is deteriorated although the wood is in good condition. The eave should be repainted to protect the wood.

Prognosis: The tile roofing assembly has recently been replaced and is in good condition. With proper repairs and periodic maintenance, the tile roofing assembly, can be expected to remain effective for an additional 25 to 30 years.

- 4.1 Examine all exposed tile underlayment and replace any deteriorated underlayment.
- 4.2 Examine all tile and re-secure all loose tile.
- 4.3 Repaint all exposed wood eave components.

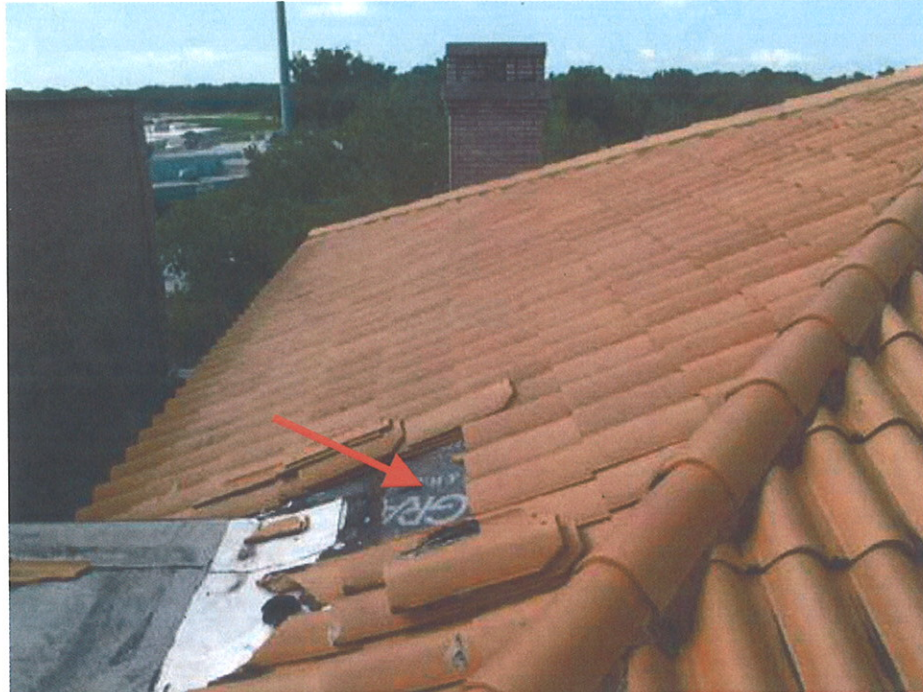
DISPLACED TILE AT THE ROOF'S INTERFACE WITH ADDITION. THIS TYPE OF UNDERLAYMENT DETERIORATES RAPIDLY WHEN EXPOSED TO SOLAR RAYS.

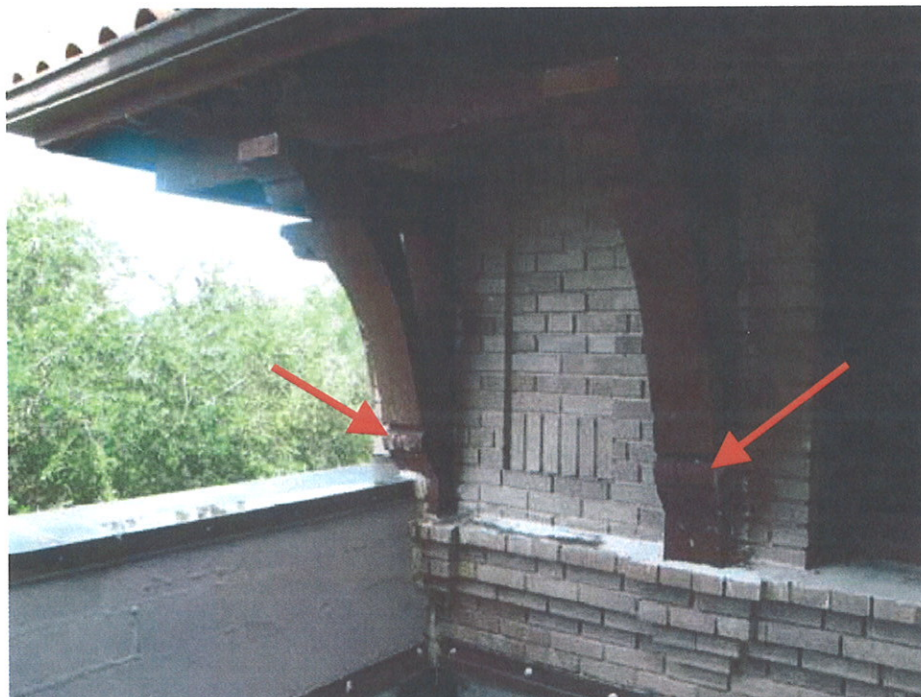
DETERIORATED PAINTED FINISH ON EAVE RAFTERS. BECAUSE OF THE PROTECTED POSITION UNDER THE TILE ROOFING ASSEMBLY, WOOD DETERIORATION IS NOT EVIDENT. HOWEVER, THE PAINT IS DETERIORATED.

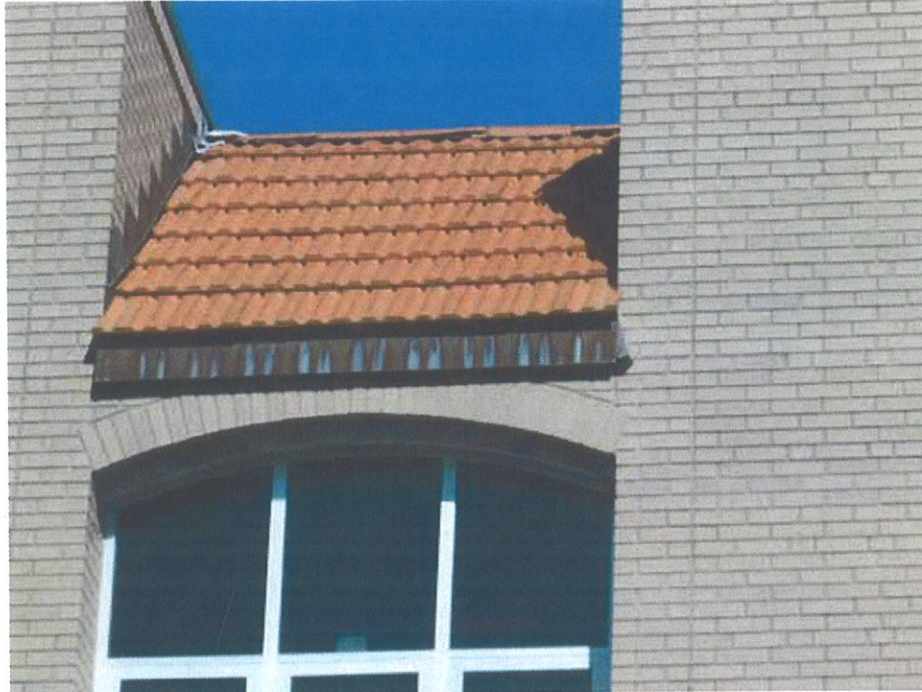
TILE ROOF ON ORIGINAL COURTHOUSE.

Assembly:	Roof Type Two of Three - Clay Tile
Assembly Location:	Steep Slope Roofs of Addition.
Assembly Condition:	Good
Component Condition:	<p>Tile: The clay tile was replaced approximately 5 years ago and is in generally good condition. The tile is mechanically attached to the substrate. Although most of the tile appears to be properly secured, some ridge tile have are not properly secured and should be reattached.</p> <p>Underlayment: The underlayment appears to be properly installed and is functioning as expected..</p> <p>Metal Flashings: The copper flashings are in good condition.</p>
Prognosis:	The tile roofing assembly is in good condition. With proper repairs and periodic maintenance, the tile roofing assembly, can be expected to remain effective for an additional 25 to 30 years.

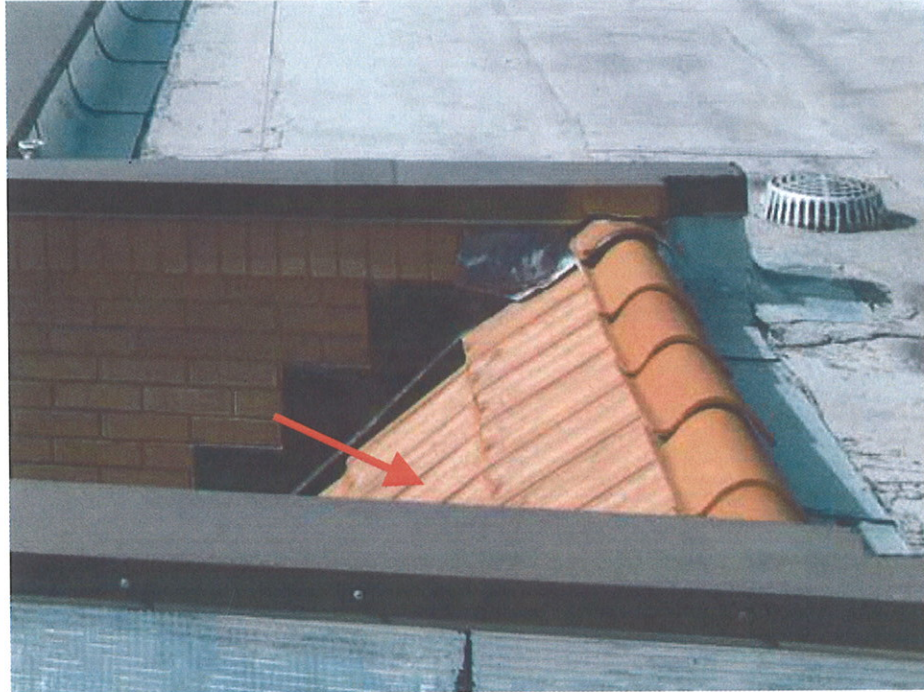
TILE APPEARS TO BE PROPERLY INSTALLED.

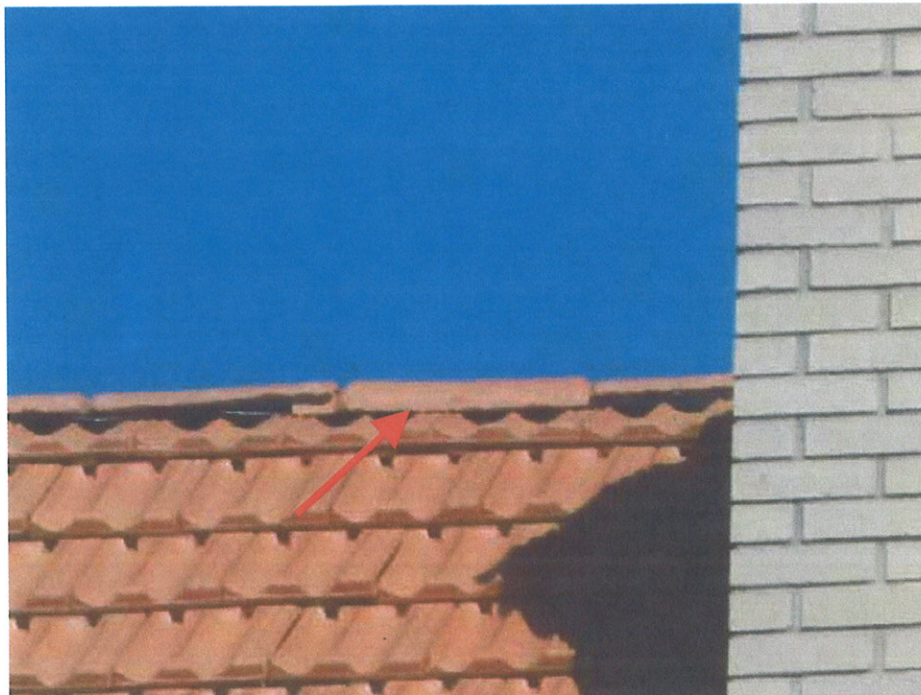
SEVERAL RIDGE TILE APPEARED TO BE LOOSE.

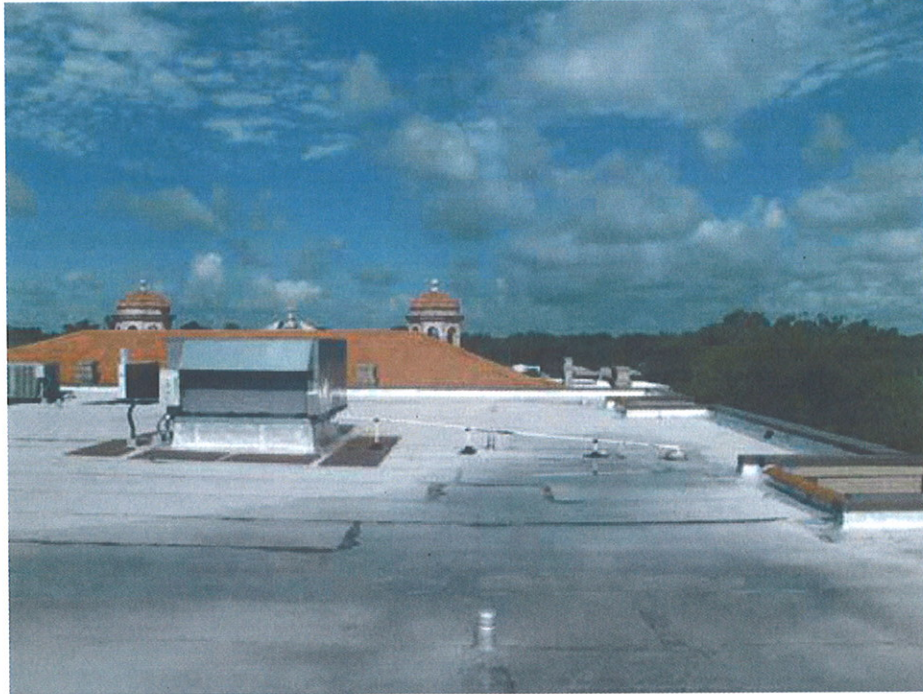
MODIFIED BITUMINOUS ROOF ASSEMBLY ON ADDITION.

Assembly: Roof Type 3 of 3 - Modified Bituminous Roof Membrane of Addition.

Assembly Condition: Good

Component Condition: **Modified Bituminous Membrane:** The membrane is in good condition with excellent granule embedment, high pliability, and proper interplay adhesion. Some areas of the roof pond rainwater and will prematurely deteriorate without correction.

Prognosis: The modified bituminous roofing assembly was installed approximately 5 years ago and remains in good condition. With proper repairs and periodic maintenance, the this roofing assembly, can be expected to remain effective for an additional 15 years.

- 5.1 Conduct roof maintenance including the cleaning of all roof drains..
- 5.2 Contact the manufacturer of the roof membrane to provide a written report of the roof condition and include any required repairs or maintenance necessary to maintain the current roof warranty.
